Winter Weather and Water Damage

By Michael L. Allen

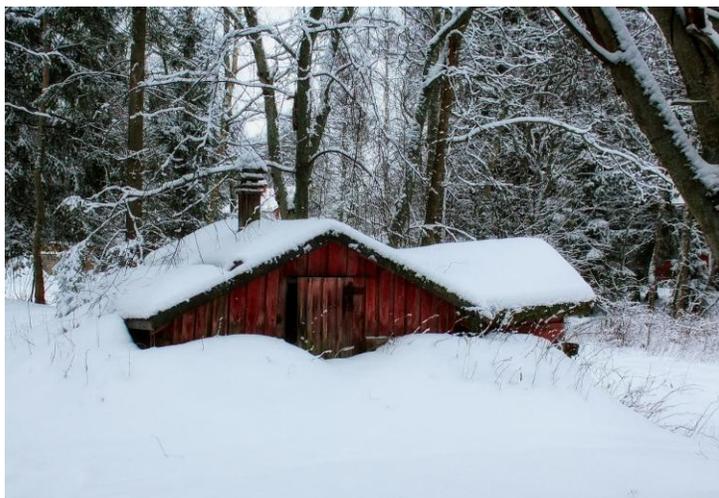
When freezing rain, sleet, and/or snow accumulates on a roof, a cycle of melting and freezing occurs. In a perfect world, the snow and ice would melt, flow off the roof into the gutters, and then drain harmlessly to the ground. However, two key factors can interact with this cycle and cause problems: the outside air temperature and the temperature inside your attic.

Under the right conditions, the interaction of these two temperatures can result in a “perfect storm” of conditions leading to property damage. The warmer the attic, the more melting will occur. Normally, as stated above, this runoff would harmlessly drain to the ground. However, when the outside air temperature is very low, the temperature at the edge of the roof stays below freezing,

causing the water runoff to freeze when it reaches that point. The resulting ice then forms a line, or “ice dam,” at the edge of the roof. As more snow melts, more water reaches the ice dam, where it also freezes, compounding the original ice dam. This cycle continues and the dam continues to increase in size, until the ice dam gets large enough to cause the melting snow to pool up behind. As this pool thaws and refreezes, it can force its way back under the roof shingles, causing them to distort, lift, and possibly tear. The ice which forces its way between and under shingles will then begin melting into the property’s attic. Ice dams are insidious in that not only do they damage your roof and attic with ice, but as the ice comes into contact with the warmer attic air, interior ice melts, causing water damage to the attic, insulation, and ceilings below.
